## Case Study: Itasca, IL Public Works Facility

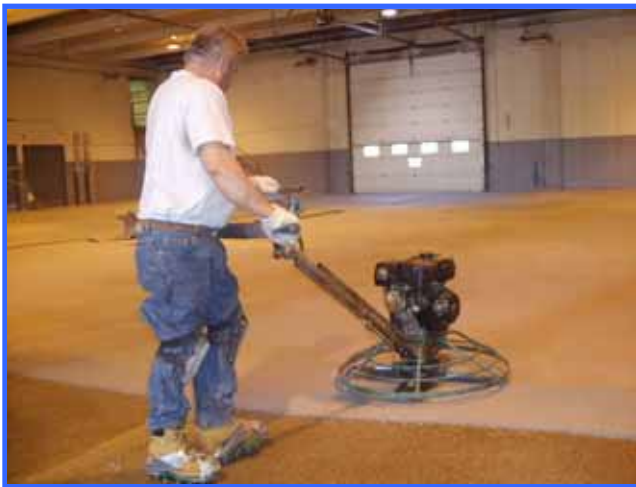
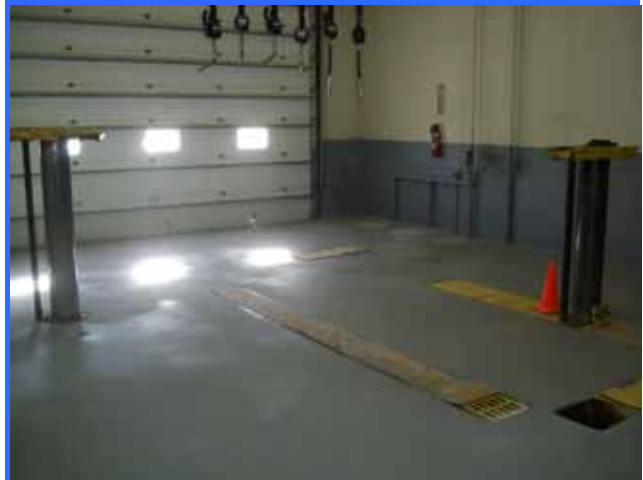
When the Fleet Manager for the Village of Itasca needed to repair the floor in their 16,000 s/f garage/storage facility in tight time frame he turned to International Coatings for guidance. The facility is used to store their trucks, plows and heavy equipment and the floor is subjected to a lot of abuse, very heavy wear conditions, moisture and oil. He was seeking an environmentally friendly, long lasting, high performance floor that required a minimum of maintenance and he wanted it done right the first time so they wouldn't be bothered with frequent repairs. ICO-Floor 51, International Coatings 100% solids, trowelled epoxy flooring system was exactly what he was looking for. Its outstanding toughness, lack of odor, and single step application make it the ideal floor resurfacer in existing facilities such as this.

Concare of Melrose Park, IL was chosen as the applicator for the job. The first step in the surface preparation was degreasing contaminated areas, followed by mechanical shot blasting to obtain a clean, abraded surface. All cracks 1/8" and greater were routed out and keyways were cut around the perimeter of all drains, trenches, metal protuberances and entryways. The floor was then primed with International Coatings 100% solids epoxy primer ICO Primer LV with rollers at an application rate of about 200-250 SF/gallon and allowed to dry tack free. Then ICO-Floor 51 was mixed and spread out on the floor using a screed box at 1/4" thickness, then power-trowelled (see photo) to level the surface and back rolled with an isopropyl alcohol-moistened roller to close the surface. Sand was then broadcast onto the floor until the preselected texture was achieved. No sealer coat was needed because of ICO Floor 51's resin rich mixture. Lastly the yellow safety striping and parking lanes were added using our high build, high wear ICO Floor Coating SY which was put down in a single coat.
