Case History – Ste. Michelle Winery

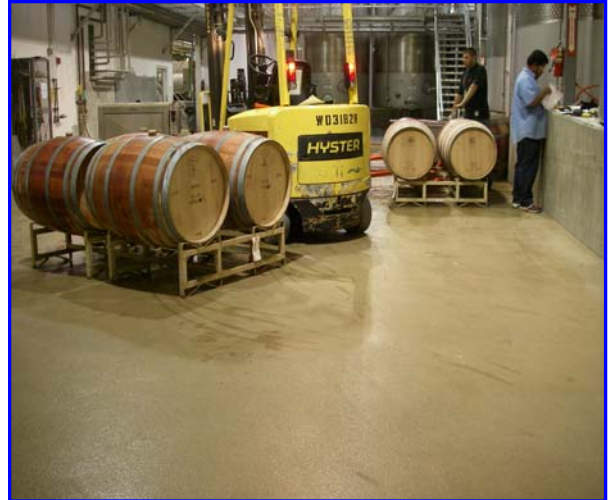
Ste. Michelle Winery also did not want an "industrial" look so Baldy recommended using local, light brown "Monterey Sand" and clear resin to provide a decorative, more natural look.

Coatings Unlimited first prepped the concrete by removing any existing coatings and getting a clean sound substrate so the epoxy could bond properly. They then mixed the resin and sand at ratio of 1 to 1 by volume. The slurry was then poured on the floor and trowelled to a smooth surface. Next they broadcast an equal amount of sand as used in the slurry until refusal. A squeegee coat of resin was then applied and broadcast into it again for a more uniform even look. Lastly after removing any loose sand and vacuuming the surface they applied a topcoat of the clear ICO Floor resin to get the desired finished texture.

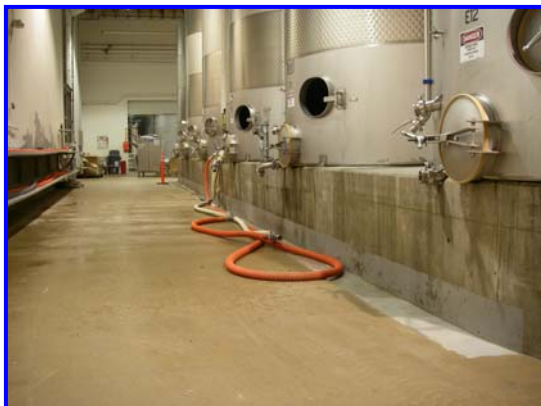
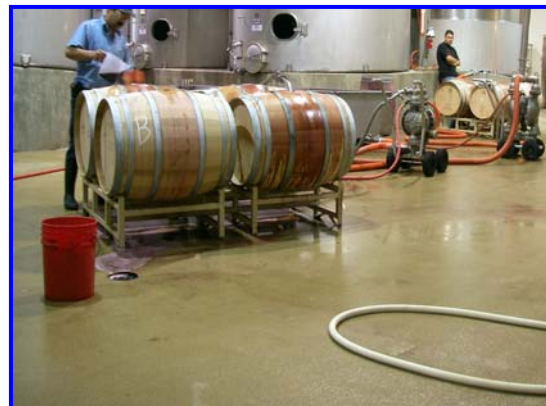
The floor has been down for over a year now and Ste. Michelle Wine Estates is very pleased with the performance of the floor and plan on having Coatings Unlimited do more work in the future.
