## ICO Case History– Shower Coating System

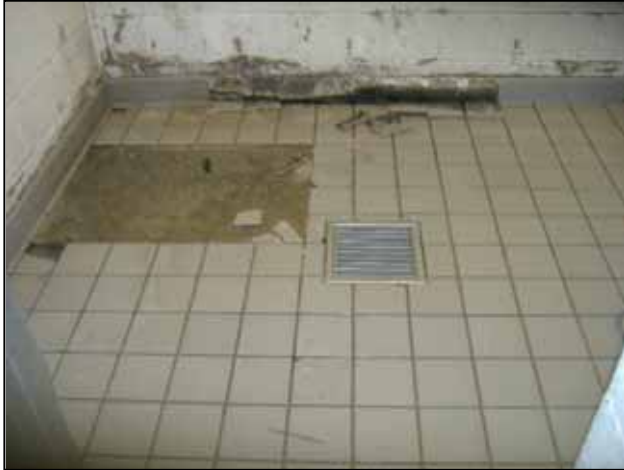
Tile Before

Mike has found that many institutions all had the same issues with the grout between the tiles quickly deteriorating because of the shower's constant use and aggressive cleaning by the housekeeping staff. Once the showers begin to leak the threat of mold, bacteria and mildew in the porous grout and the substrate below then become a major health concern. Removal, disposal and replacing the old tile and damaged walls is very costly and still has the problem of grout failure in the future.

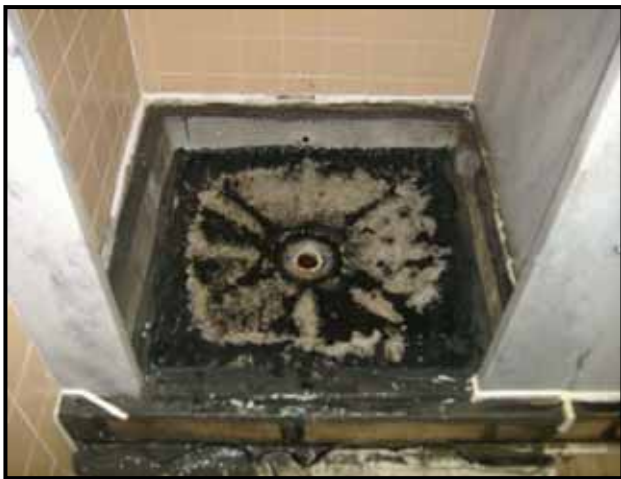
Shower Pan Before

Another common issue Mike sees is where they tried to use acrylic pans over the original shower base to stop the leaking. The caulk sealing around the acrylic pan inevitably fails and moisture gets between it and the original shower pan. As you can see from the picture above mold and mildew become a serious issue. Constant recaulking of the showers proved to be an expensive and short term answer. Mike's solution is to completely remove the acrylic pan, clean all the mold and mildew build-up, and grind the original shower pan. Next he fixes any cracks with **ICO Gel** and then primes with **ICO Primer LV** and applies two coats of **ICO Glaze**. This has proved to be a permanent solution that has saved his customers thousands of dollars in maintenance and repairs.
