ICO Case History – S.C. Johnson & Sons, Racine, WI

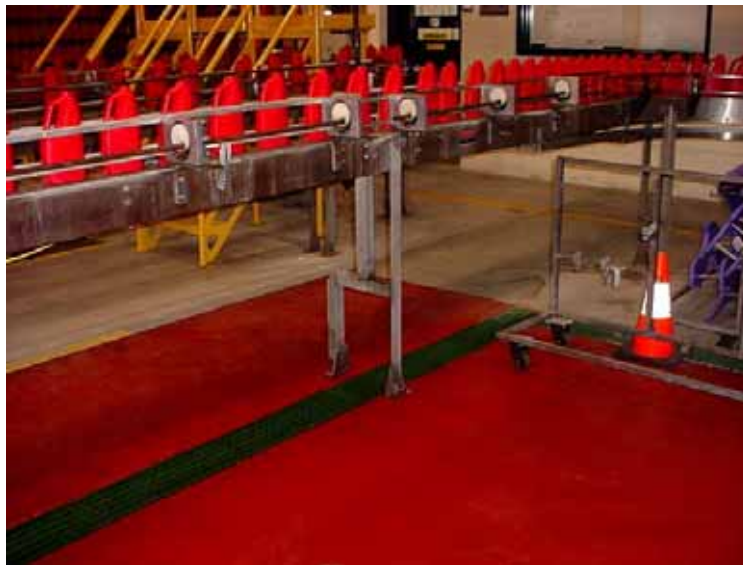
S.C. Johnson & Sons in Racine, WI was having problems with their floors around their Drano products filling lines. Occasional spillage of the Drano was deteriorating their previously installed floor coating and making the floor very slippery, creating unsafe working conditions. Their Engineering Product Manager was looking for a floor coating that could stand up to the corrosive properties of Drano while being safe for his employees to walk on while wet and easily cleanable.
