ICO Case History– Mars Pet Care

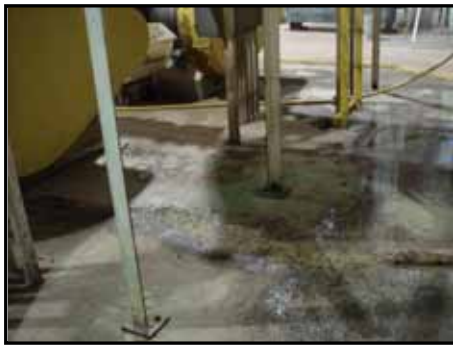
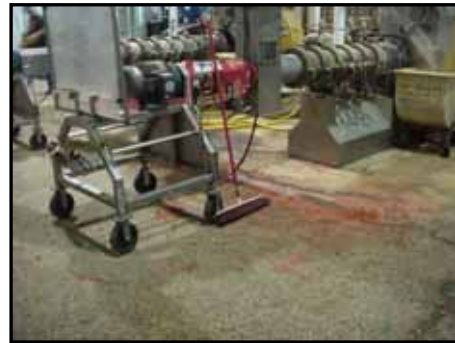
The area with poor drainage was about 1,200 square feet directly under two pieces of production machinery that cut the food into pieces. The machines could not be shut down for long periods of time or the whole operation would come to a stand still. The entire floor about 35 feet out from the drain had to be sloped.

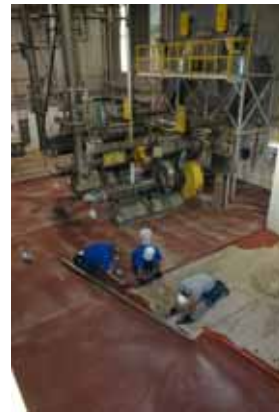
Tom and his crew first removed the old existing coating and prepped the floor by grinding it they had clean, sound concrete. Then in one step they trowel applied the ICO Guard 51 from about 2" thick down to about 1/4" thick around the drain to achieve the slope needed for the area to drain properly. Needless to say the Plant Manager has been extremely pleased with the quality of the material and work.
