INTERNATIONAL COATINGS INC.

Case History: Enterprise Transport

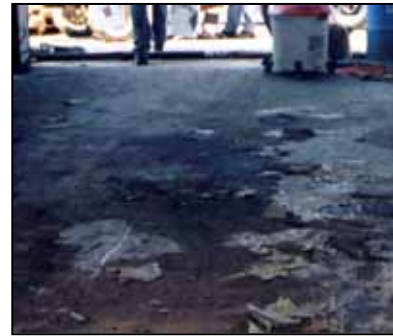
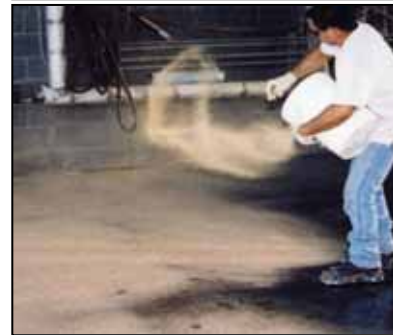
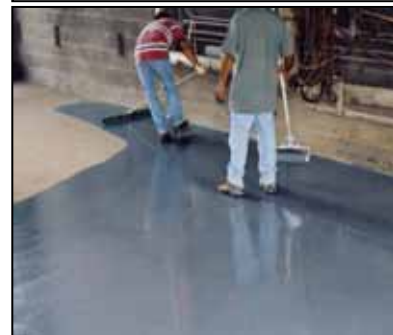
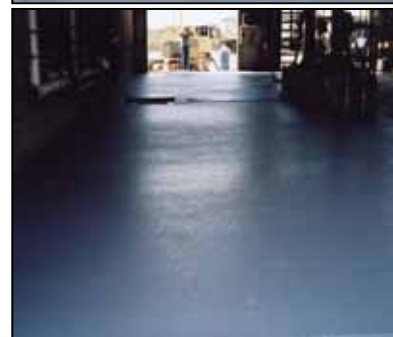
Bruce Parker, Director of Maintenance and **Mike Leggio** Terminal Manager of the Gulfport, TX terminal were experiencing failure with their current floor coating after only two years and the walls of the sump for the trench drain had collapsed. They were also concerned for the safety of their employees because the floor had very little traction and would get slippery when wet. The trucks are washed with a cleaner, which is determined by what they are carrying and then rinsed with hot water inside and out. The strong cleaners as well as corrosive materials hauled in the trucks in combination with the abrasion from the dirt and gravel tracked in from the parking lot were attacking their floors. The current coating was too thin and was not installed properly for the conditions. They had met **Bert Downing** of International Coatings when he spoke at the Assoc. of Haulers national convention and decided to give him a call.

Bert brought in **Tom Burk** and **Rick Jones** of **Plant Maintenance Services**, certified contractors out of Houston, TX to help fix the problems. The first step was to thoroughly remove the old coating and clean the floor; this was done with a combination grinding, pressure washing and shot blasting. All joints and cracks were routed out to remove failing joint fillers and coatings then they were saw cut.

Outside perimeter edges were saw cut and keyed. The wall that had collapsed was removed and a fiberglass sump was prefabricated by the contractor then set in place. The top edge flange was sealed with ICO-Hi Guard and reinforced with fiberglass fabric. After all detail work was done a coat of ICO-Primer LV was applied and allowed to dry tack free. Then dark gray ICO- Hi Guard was applied using a slurry/broadcast method to achieve a ¼" total thickness. ICO- High Guard was chosen because of its excellent chemical resistance and ability to stand up to thermal and mechanical shock. The job was done over two weekends with each session starting Friday evening and ending Sunday afternoon with traffic resuming first thing Monday morning. The end result was exactly what Bruce and Mike were looking for - a durable floor that could withstand the harsh conditions and remain safe for their employees to walk on when wet.
