INTERNATIONAL COATINGS INC.

Deteriorated concrete in a gold mining operation restored by application of novolac epoxy liner and trowelled flooring.

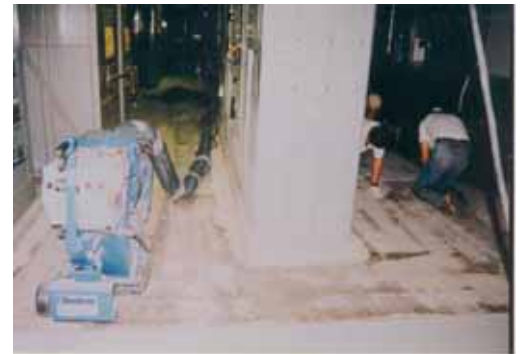
Gold mines present a particularly corrosive environment with constant usage of 98% sulfuric acid, together with infrequent washdowns. In addition, the areas are subjected to extremely heavy forklift traffic. Severe erosion was present in both vertical and horizontal surfaces, in some cases up to 2" deep. To compound the problem, time constraints were very severe, due to continuous mine production, with downtimes limited to no more than 72 hours.

Floors and walls were sandblasted to remove all degraded concrete and provide a sufficient profile. The surfaces were then primed with **ICO Primer LV**. Since much more material was removed on the vertical surfaces than expected, the **Hi Guard Liner** had to be thickened up with silica flour, which enabled application of the liner up to 1/2" thick in certain areas. Similarly, the **Hi Guard** flooring material was applied in a single pass up to 2" thick. The ability to apply both products in a single pass enabled the area to be returned to service within the allotted time of 48 hours.

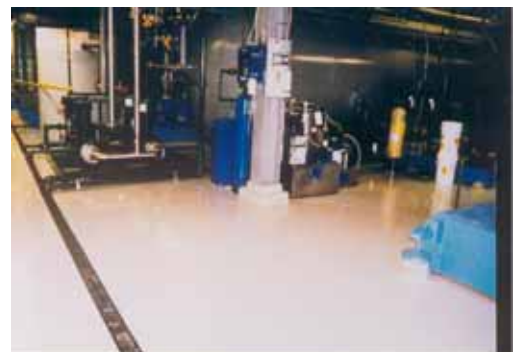
The customer was extremely pleased with the timely completion and performance of the material. No failures of the product have been noted after almost two years of service.
