## INTERNATIONAL COATINGS INC.

### Case History – BNE ICO Floor 51 Power Trowel Installation

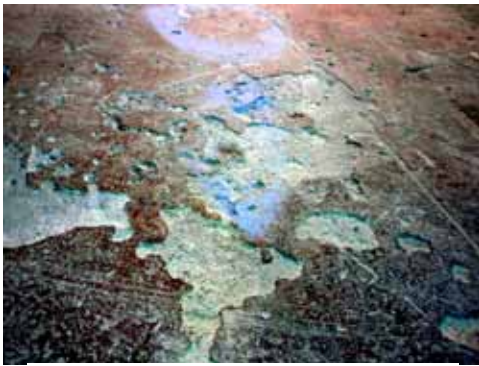
Old Coatings

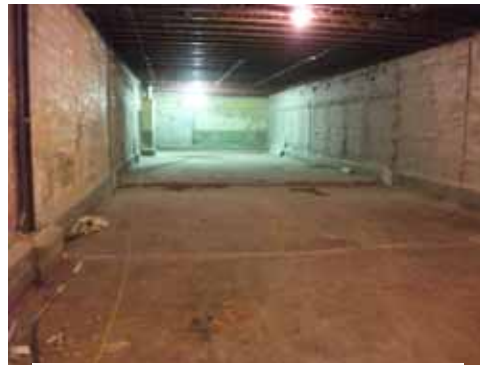
Dry Storage Area

In all they recommended three different systems: **1.)** 4,000 sq/ft of ICO Floor Coating applied with a full broadcast and topcoat with slip resistant texture for a total of about 40mils thickness in a dry storage area, **2.)** 30,000 sq/ft of ICO Floor 51 power trowelled at a ¼" thickness and top coated with ICO Floor Coating finish for improved aesthetics and added a slip resistant texture in the processing area; and **3.)** 2500 sq/ft of Ureguard TL applied at ¼" thickness in a fryer area.

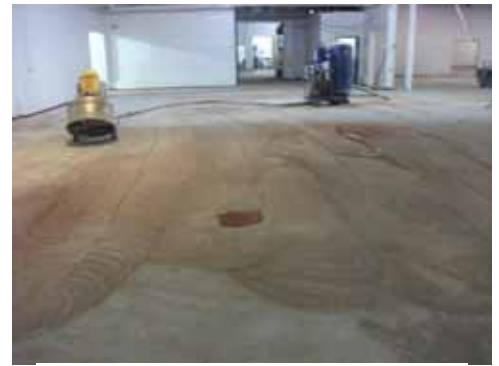
Grinding the Floor

The first step involved milling off approx 18,000 sqft of ½" – 1.5" sloping materials, old floor leveling materials and resurfacers. They used a 20" shotblaster, 10" scarifiers, 32" diamond grinders and a 16" milling head that was driven by a bobcat to prep the floor. ICO Primer LV was applied at about 250 sq/ft per gallon on all the surfaces. There was no need for patching because they were able to fill low spots and holes with the ICO Floor 51 while power trowelling. Even though they were new to power trowelling a resin rich system they completed 5,000 sqft using a crew of six on the first day and got better as the job went on.
