### **Featured Installation: Milwaukee County, Wisconsin, ICO Quick-Patch**

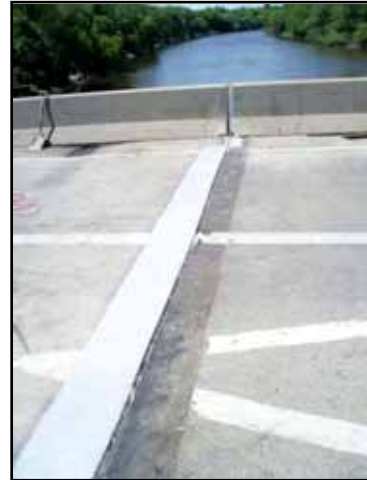
Steve Martinez, Structural Maintenance Specialist for the Wisconsin Department of Transportation, had several joints on a bridge approach that were in need of repair. There was polymer concrete on either side of the joints that was failing and pieces had begun breaking away. Moisture was able to penetrate these cracks and freeze thaw combined with heavy traffic exacerbated the problem.

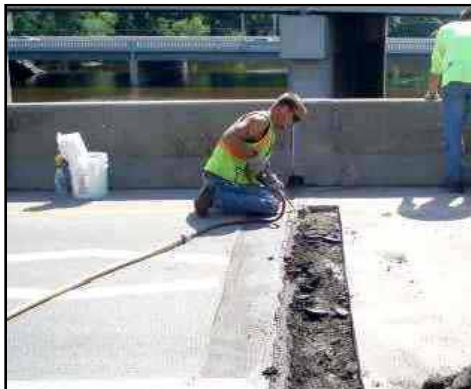
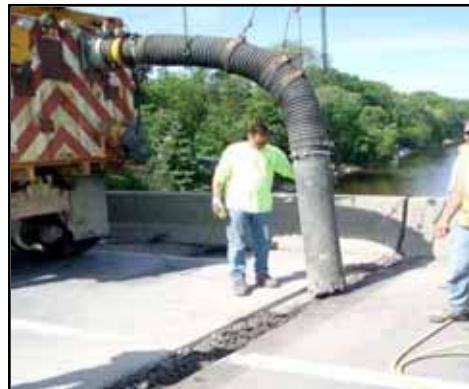
At 9am the bridge was closed to traffic and crews immediately started to remove the old patching material and any deteriorated concrete using air hammers. Because of the moisture penetration, salt attack and freeze thaw cycles, a lot more concrete had to be removed than originally anticipated. ICO-Quick Patch can be applied in virtually any thickness so this was not an issue. A large vac truck was used to expedite the removal of the concrete and loose debris.
