INTERNATIONAL COATINGS INC.

Case History – Con Agra Foods, Longmont, CO

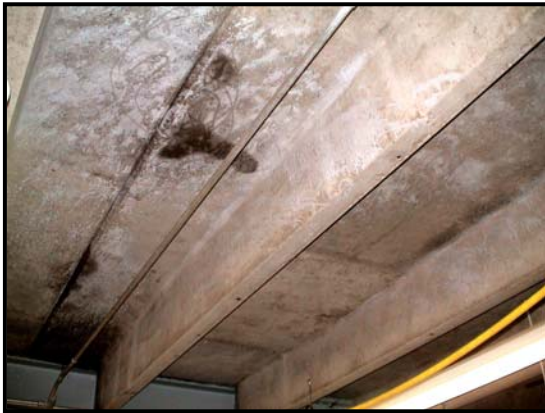
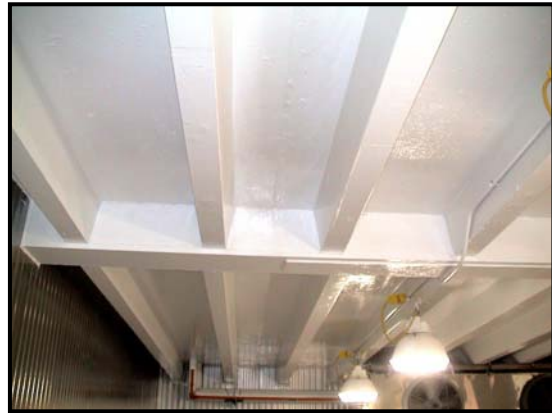
Ted Johnson, the plant engineer in charge of the modernization program, asked Tom to turn his attention to a 5000SF cooler room that not only had many layers of previously applied polymer floors that were constantly patched, as well as uncoated concrete T-panel ceilings that proved difficult to sanitize.
