## Featured Installation: Reliable Plating Company

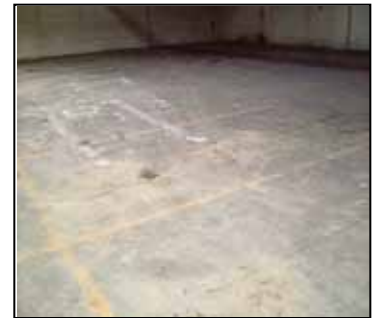
The first step in the rebuild was to repair and coat the existing concrete floor to provide a bright, tough, chemical resistant, seamless surface that would be easy to maintain and provide a safe walking surface for their employees. The floor system had to be able to withstand the plating solutions containing strong acids, strong bases, metals and cyanide salts. After meeting with several floor coating manufacturers they chose a system recommended by International Coatings and certified contractor **ConCare**. The recommended system consisted of one coat **Primer LV FC** followed by **ICO Primer SL Slurry** applied at 1/8" thickness to fill low spots, spalled areas and other irregularities. Finally 30 mils of **ICO Hi Guard Guard Coating**, a novolac epoxy for optimal corrosion protection completed the system.

The installation started with ConCare preparing the concrete by blasting and hand-grinding to provide a clean sound substrate for the epoxy to bond to. All cracks and larger holes were spot repaired and a coat of **ICO Primer LV FC** was applied to create an integral bond between the concrete and the coating system. Next they applied the **ICO Primer SL Slurry system** at a 1/8" thickness using a notched squeegee. The chemical resistant topcoat, **ICO-Hi Guard Coating** in Royal Blue, was applied in two 15 mil coats to achieve the total 30 mil desired thickness.

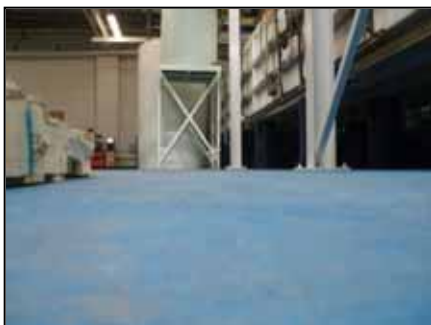
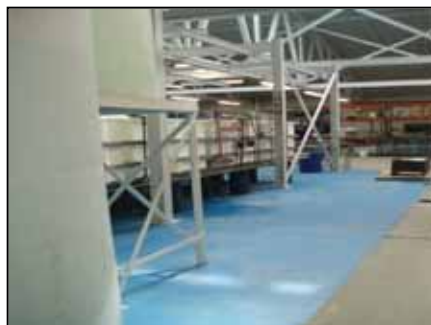
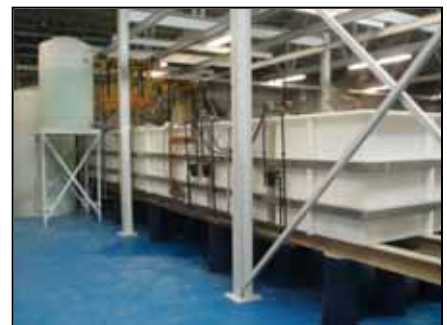
The floor was finished in the fall of 2007. They also installed a brand new skylight to provide natural light as well as new lighting. The wooden rafters and walls were painted with a white corrosion resistant paint to further brighten the room. A second floor addition for additional office space is also planned. Production started in the building spring of 2008 and Reliable Plating has been pleased with the performance of the floor to date.
