ICO Case History – Hyatt Hotel, Long Beach, CA

Background

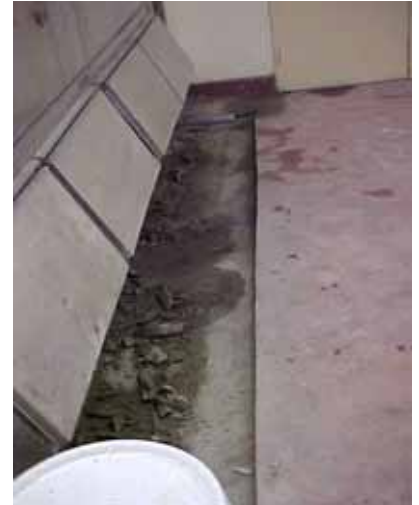
Because of some of these disadvantages the Hyatt Long Beach, under the direction of Allen Balian, Chief Engineer, had previously installed a monolithic epoxy floor in their main kitchen. While the majority of this floor was still intact, it had been repeatedly patched, especially under the hot kettles, and had shown signs of pitting around the fryers. In addition, the floor was judged too slippery for kitchen operations. Initially, we were asked to patch objectionable areas, with the longer term objective of resurfacing the entire floor and coves to improve the overall appearance and safety of the kitchen.

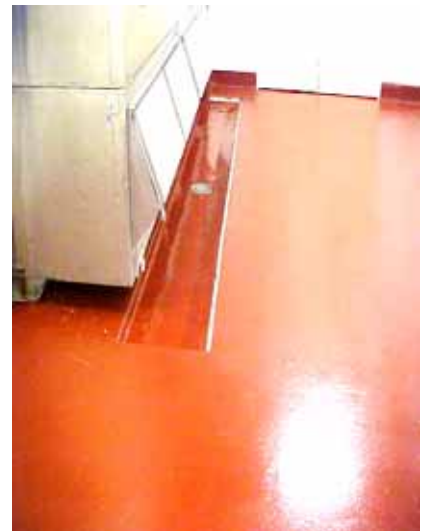
Kitchen floors present a particularly severe challenge to flooring materials, with a combination of chemical cleaners, heavy wear, thermal shock from hot steam kettles, safety concerns, and lack of downtime to accomplish the repairs. Fortunately, adequate downtime was to be provided during their slower holiday period. However, other criteria that Allen set forth included: a five year warranty, an aesthetically pleasing floor that would be easy to clean but also be safe for employees and an integral cove base.

Based on the customer requirements, we specified our Guard 51 seamless flooring, applied at ¼” thickness. This product was selected because of its lack of odor, impermeability to liquid penetration, chemical attack, and excellent thermal shock characteristics. With the added concern of overall appearance, safety and ease of cleaning, the slurry/broadcast system with red color quartz aggregate was selected since it yields a flat, uniform appearance with better color retention. The topcoat of ICO Guard Coating would improve the cleanability of the floor and to further hide dirt and grit, a final clear coat of ICO Sealer was applied at about 10 mils thickness, leaving a fine texture for traction control.

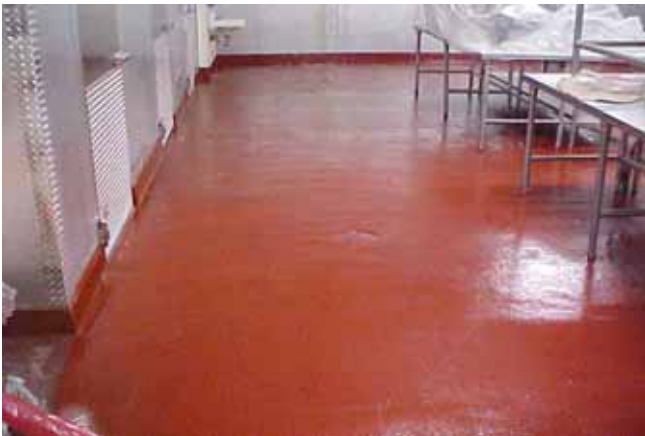
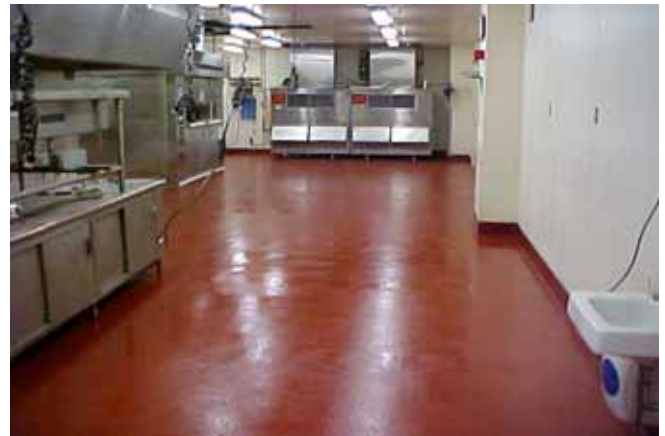
Because the 160 SF area under the hot kettles and adjacent steamers could see direct flames, it was decided to install quarry tile over our ICO Lastic membrane and over ICO Grout BL epoxy bedding material. For better high temperature resistance, ICO Hi Grout TS was specified for filling the joints.

Installation of the 6000 SF floor occurred, over a seven day shutdown period. The contractor first degreased the old floor followed by diamond grinding the floor and well adhering quarry tile coves. Any loose flooring was completely removed and patched with ICO Guard 51. Loose quarry tile cove pieces were removed completely, a cement board backer installed, and then our ICO Guard coving base installed over it. All metal was ground and keyways cut around metal legs, metal pipes and termination points.

The ICO Guard liquid resin was applied at about 35-40 SF/gallon and seeded with silica sand. After allowing to dry, excess sand was vacuumed off, the floor screened to remove high points, and then the Guard resin was again applied as a slurry, at the same coverage as before, but this time seeded with a red color quartz to refusal. After allowing to dry, the floor was vacuumed, screened and then coated with ICO Guard Coating at about 80 SF/gallon. For enhanced cleanup, a top coat of clear ICO Sealer was applied at about 10 mils thick. Expansion joints were recut, filled with a closed cell backer rod and topped off with ICO Lastic Gun Grade caulk. Quarry tile coves received two coats of the Guard Coating and the clear top coat.

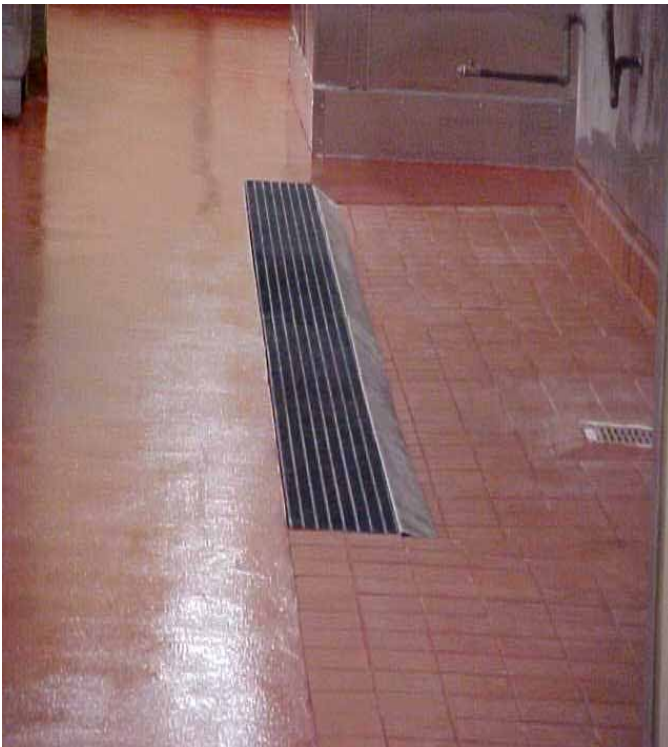
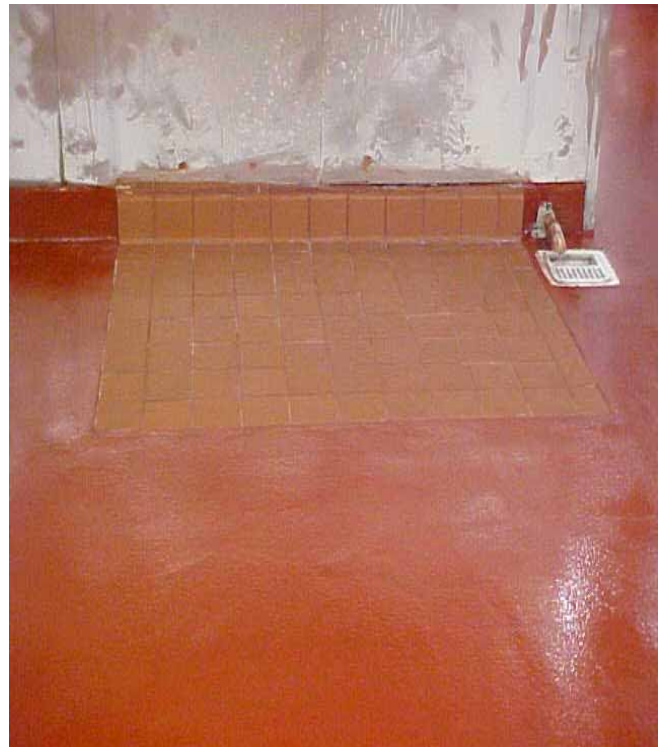
The 6000 SF project was completed within the seven day shutdown period. The customer was very pleased with the results, particularly the absence of odor of the material and the ability of the contractor to minimize dust during preparation. After viewing the performance of the floor for several months, a second “tide” kitchen was resurfaced in a similar fashion. After almost a year of use, the floor has held up well and has provided the safety and appearance desired by the customer.
