Case History: Papé Machinery

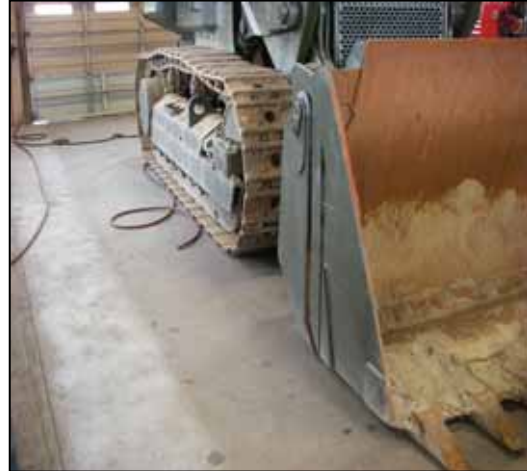
Papé Machinery is one of the west's largest construction and forestry equipment suppliers and has been around for almost seventy years. One of their dealers and service centers in Tacoma, WA was having problems with the concrete floors in their service bays. The floors were being badly damaged from the heavy equipment moving in and out, including large machinery having steel tracks and chains that provide traction in the mud and snow. These steel treads and chains in addition to the heavy weight of the vehicles were severely gouging and damaging the concrete. Darrin Ishaug, the Service Manager of Papé, contacted **Marty Hogan** of **Dunkin and Bush**, an International Coatings Certified Contractor, to see if they could come up with a solution to the problem.

Dunkin & Bush had installed International Coating's ICO Floor 51 system at Coors Brewery in Virginia with great success. They knew ICO Floor 51 was a tough and resilient material and thought International Coatings could help customize it so that could withstand the conditions at Papé Machinery. **Marty** and ICO representative **Tim Rayburn** devised a system that used the ICO Floor 51 at a ¼" thickness but in the areas where the heavy steel tracks would contact the floor they combined a steel filler with the usual ICO Fill hand trowelled sand to make the system even more abrasion resistant

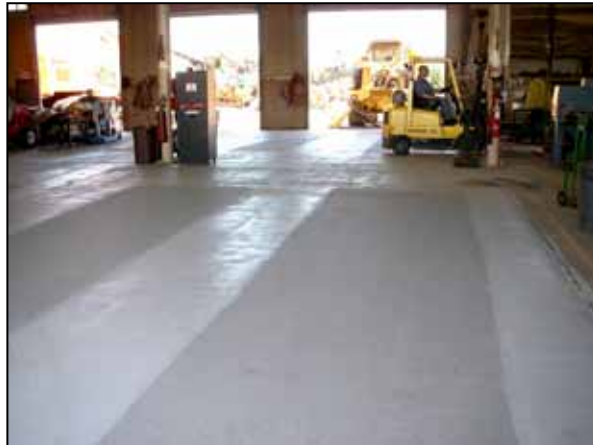
A test patch of ICO Floor 51 with the steel filler was put down at ¼" in one of the service bays. It was heavily abused for two-months and held up great with no problems. Papé was impressed enough with the systems toughness and durability and decided to have it installed in the rest of the facility.

Dunkin & Busch installed # sq/ft of ¼" topping, in three separate four day periods so some of the bays could remain operational while they were doing the installation. They first thoroughly washed the concrete with a citrus-based cleaner to remove any oil and fluids from the concrete. They then blast-tracked the concrete to obtain a clean, sound, abraded surface for the epoxy to bond with. They also routed out any cracks and pre-filled some of the deeper holes and more severely spalled areas with the ICO Floor 51.
