ICO Case History – Concrete Protection for Detention Centers

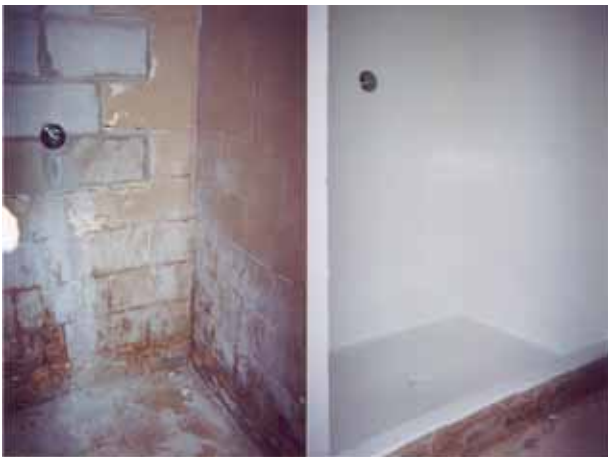
Showers: Before and After

There are some specific areas that historically offer the greatest and most frequent problems because the conditions include daily use, under wet conditions, with a need for sanitary conditions. Good examples are shower areas, kitchens, and cafeterias. We have never encountered any personnel that did not complain of the problems of maintaining these areas prior to the use of **ICO Floor Coating** on the floors and **ICO Glaze** on the walls of shower stalls. The first picture reveals shower stalls at the Hampton County Detention Center in Hampton South Carolina. The paint was constantly peeling and required recoating every 6 months. In paint off the surface down to a solid, clean substrate. In this application the **ICO Glaze** system, including **ICO Gel** to smooth the joints was applied on the walls. The contrasting photo is **ICO Glaze** after 4 months of use. The striking difference is testimony to the tough, mold, graffiti and damage resistant characteristics of **ICO Glaze**.

The floors have added difficulty as they are subjected to harsh cleaning, constant traffic and must be skid resistant. The best performing material found by institutions for this area is the **ICO Floor Coating** also seen in the finished photo. The system includes **ICO Primer LV**, and two coats of the **Floor Coating**. The first coat receives a broadcast of aggregate to provide the required skid resistance needed in shower areas.

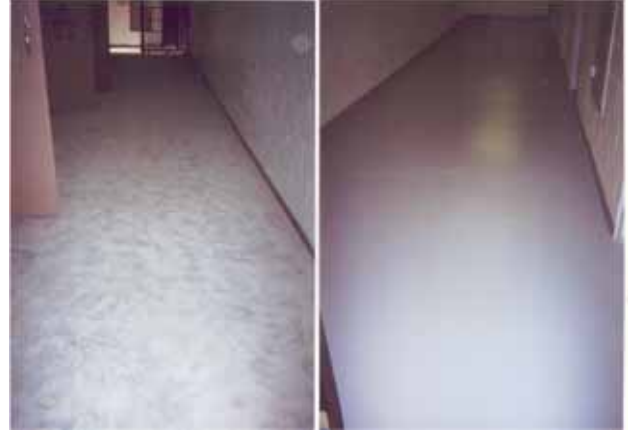
Hallways: Before & After

The same coating **ICO Floor Coating** is an excellent covering for hallways, cafeterias, and cell floor. The second of pictures shows the use of **ICO Floor Coating** in the Georgetown Detention Center in Georgetown South Carolina. Also shown are hallways that were sealed with only **ICO Primer LV** to minimize costs while maximizing performance and facilitating the ease of cleaning and maintaining the floors.
