INTERNATIONAL COATINGS INC.

CASE STUDY: SOUTH DAKOTA AIR GUARD HANGER

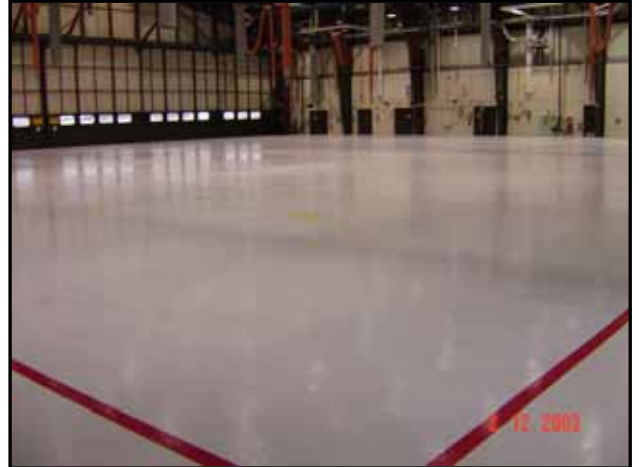
The South Dakota Air Guard's hanger floor in Sioux Falls had been previously coated on several occasions. As a result of poor surface prep the Guard was left with a very uneven floor that not only looked unsightly, but also made conveyance of equipment much more difficult. In addition to the floor additional needs included a high wearing safety striping material that could hold up to heavy loads and mechanical abrasion, as well as the filling of numerous expansion joints. Bumble Bee Construction out of Sioux Falls was asked for their proposal on how to solve the uneven floor problem and how to recoat the floor to obtain maximum life under a very tight budget.

- Using diamond grinders, the existing floor would be leveled and the old coating would be removed.
- A first coat of International Coatings' flexibilized, 100% solids, two part epoxy coating, ICO Floor Coating, was applied at 10 mils
- Two coats of a two part, aliphatic, UV-resistant urethane coating, ICO Ure Guard 60, were then applied at about 2-3 mils dry film thickness per coat
- Safety striping in several colors was provided using ICO Floor Coating SY at about 15 mils, applied in a single coat
