ICO Case History– Anheuser Busch Fairfield, CA

A new pasteurizer line is being installed at Anheuser Busch in Fairfield, California. Due to excellent past experience with ICO Guard 51 in the Van Nuys, California plant, Guard 51 was the preferred product for the floor of the new line by corporate engineering. ICO Guard 51 is the first product listed in the Anheuser Busch corporate flooring specification TP-70 and it has been used in their plants across the country including New York, Ohio, Missouri and Texas.

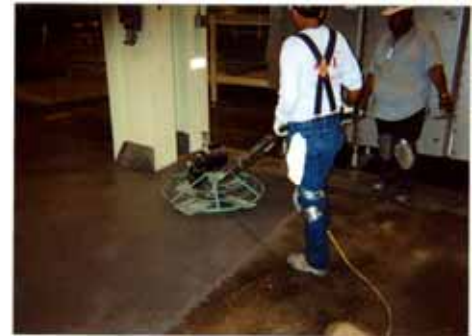
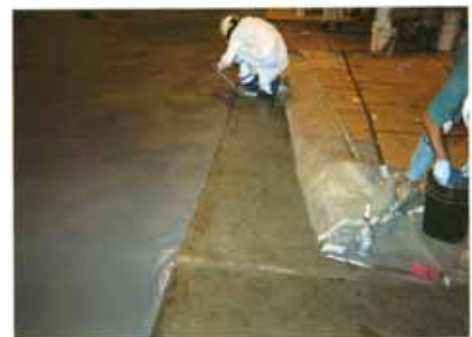
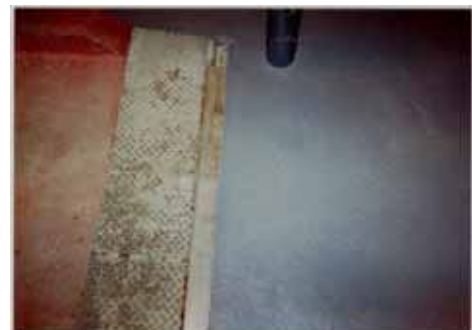
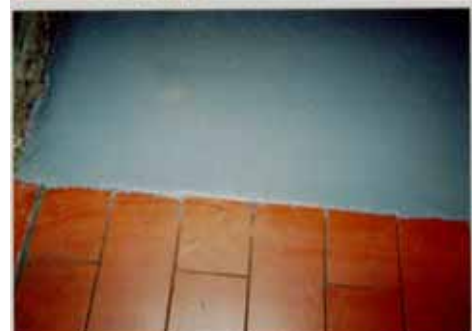
The above- photo's show the application, neatness of the contractors finish, and the smooth surface texture. The two coat system, primer plus topping in the fast cure formula provided for a very rapid cure. The project was completed precisely on schedule.

To provide a good profile the floor was shot blasted. All cracks and deteriorated areas were repaired. A key was cut around all drains and the entire periphery. The floor was primed with ICO Primer LV Fast Cure to minimize the curing period required before placement of the ICO Guard 51. At 60°F - 65°F the primer cured in 2 hours, (approximately the same time required to coat the 4,500 sq ft).

To maintain the rapid pace of application and curing ICO Guard 51 Fast Cure was applied by power trowel. The material was placed by screed box and finish trowelled by machine. No other steps were taken such as back rolling or seeding with sand. The entire 4,500 square feet required 5 hours to install. As a result the material placed first was cured as the last was just being laid down. In falling temperatures, low sixties down into the high fifties, the Guard 51 fast cure only required 4-5 hours cure for foot traffic.
