## Case History – Kearfott Corporation

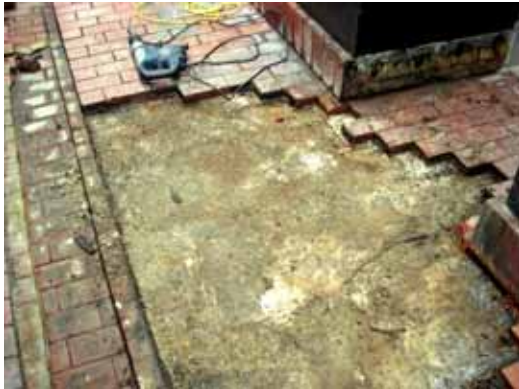
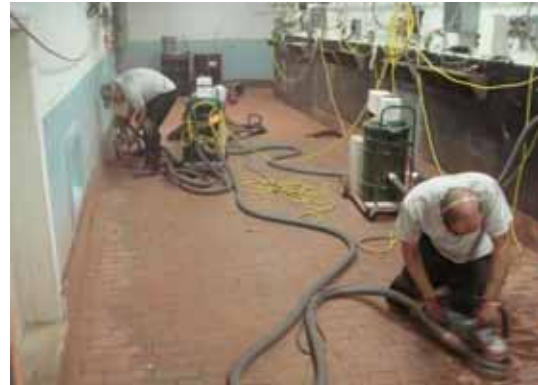
They have an area in the plant with 13 process tanks that contain many different caustics and acids. It had an acid brick floor and over the years the different chemicals had severely deteriorated the mortar joints. A new flooring system was required that could withstand all the chemicals present and provide a easy to clean and safe walking surface for their employees.

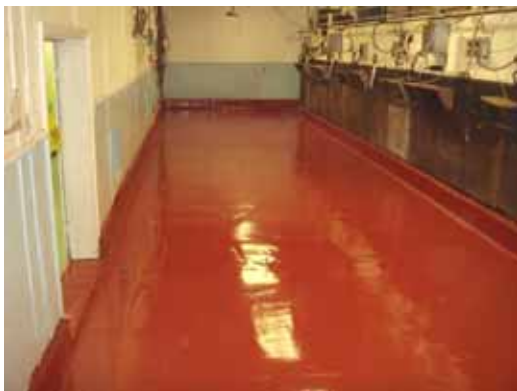
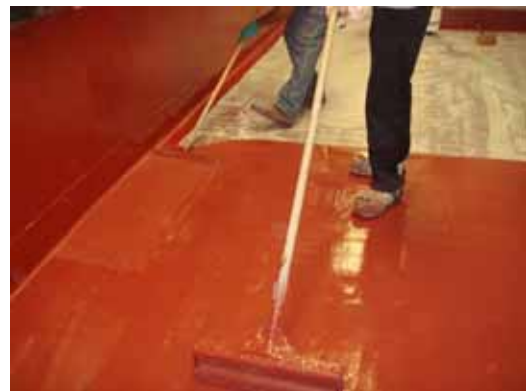
The total area was 2,500sq/ft and there is a trench that runs the length of the room. The bottom of the trench was completely eaten away along most of it down to the soil.

All the loose and badly cracked bricks and mortar were removed. The acid bricks were then prepped by diamond grinding to provide a clean and open surface for the system to bind to. ICO Primer LV FC was roller applied at about 250 sq/ft per gallon to penetrate the brick and provide an excellent mechanical bond. Next ICO Gel MC was used to fill in and smooth out all the mortar joints. This would prevent the mortar joints from showing through the coating giving the smooth finish Kearfott desired. Next the ICO Ure Guard Slurry was applied at 3/16" thickness and a topcoat of Ure Guard TL/SL coating was applied.
